NovaSeq X Plus 1.2.2 Release Notes

This document details improvements and known issues for the NovaSeq X Plus Sequencing System v1.2.2.

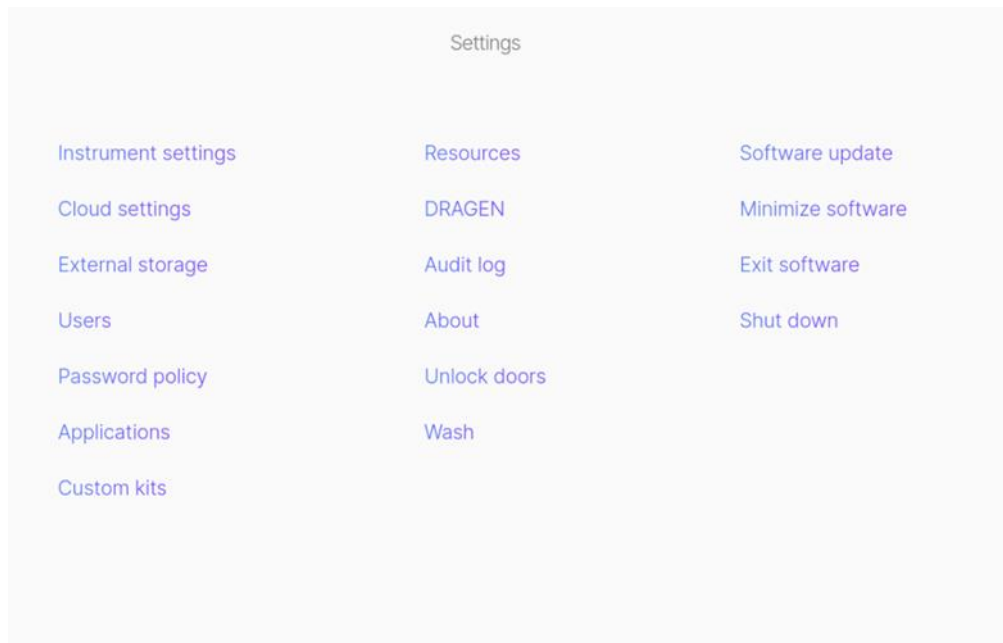
- Revised Instrument Power Cycle Guidance:
 - Power Cycling the instrument shall be performed through the control software after v1.2.2 upgrade.
 - Shut Down the instrument:
 - Go to the control software "Settings" menu -> select "Shutdown"
